Endline Evaluation of PMKSY-WDC Batch II Watershed projects
REPORT: PATTAMBI BLOCK (PATTAMBI E1)(Palakkad District)

The investigating team from CWRDM visited the IWMP IV Pattambi E1 project on 12/02/2019. Initial discussions were done with the Block officials and Technical expert. The technical Expert and respective VEOs accompanied the team in field visit. The works visited by the team were:

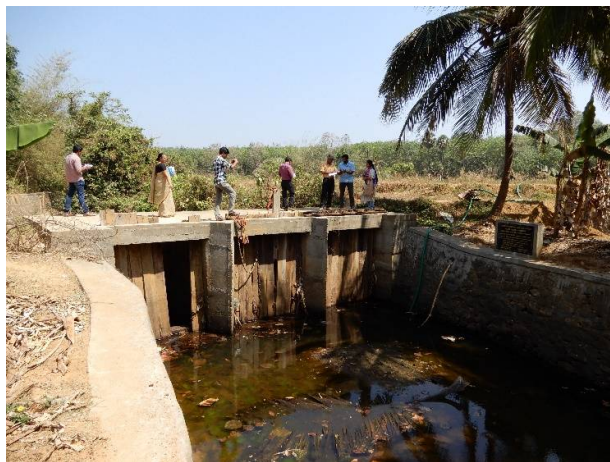
Fig 3 Kuthiramthodu side protection and shuttering

This work is located in the Kulukkallur watershed of Kulukkallur Gram Panchayath. The work was done in three reaches, the total cost being Rs. 38,89,000

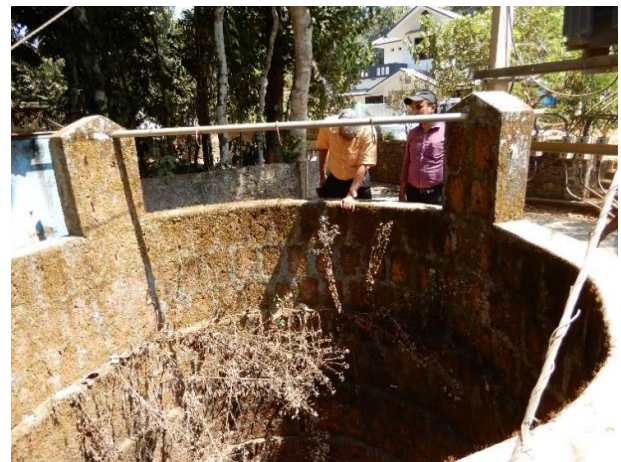
Fig2 Renovated Njandippalliyil public well

This well is situated in the Kulukkallur watershed of Kulukkallur Gram Panchayath. The renovation work was completed at a cost of Rs. 50,000. But the well appears neglected and out of use. There was no pumping being done at the time.

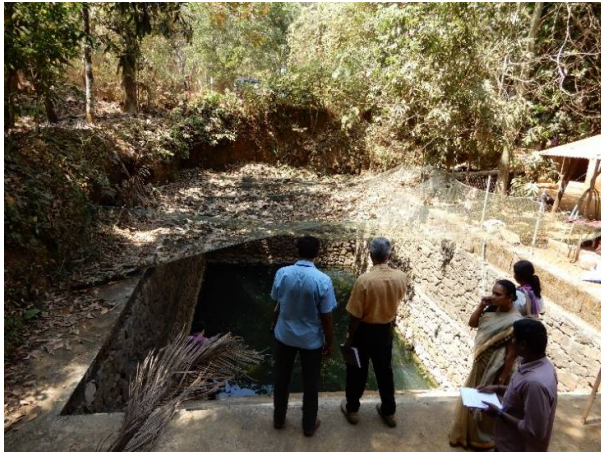
Fig 5 Renovated pond in BVUP School
Chundambatta

The pond is situated in the premises of BVUP School, Chundambatta in Kulukkallur watershed of Kulukkallur Gram Panchayath. The water from the pond is used for irrigating vegetables which are cultivated in the school compound itself. Also, swimming lessons are given to the pupil of the school in this pond. A teacher of the school has also installed a hand pump using gears, which he designed himself.

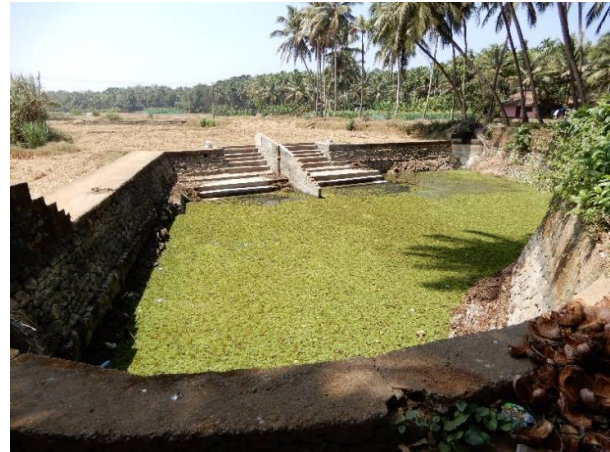
Fig 4 Renovated Puthankulam pond

This work is located in the Vilayur watershed of Vilayur Gram Panchayath. The work was completed at a cost of Rs. 8,09,100.
