Endline Evaluation of PMKSY-WDC Watershed Projects

REPORT: KALPETTA BLOCK - IWMP II F I (Wayanad District)

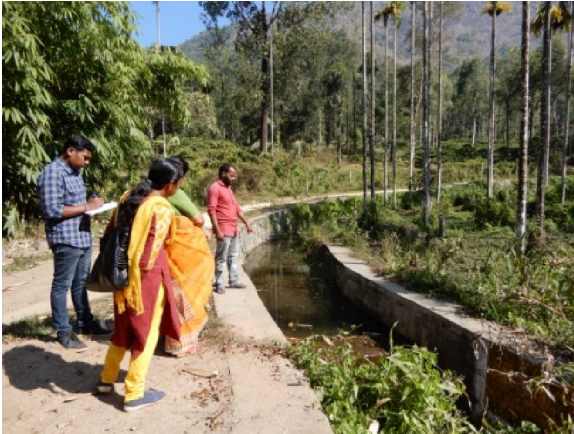
The structure is located in the Mangavayal watershed of Meppadi Gram panchayat. It was constructed at a cost of ₹ 3,00,000. The stream in which the check dam is constructed is a perennial one and nearly 25 families benefit from this structure due to the improvement in the groundwater table. But the structure faces sediment deposit problem.

Mandokkuni check dam constructed in Mangavayal watershed

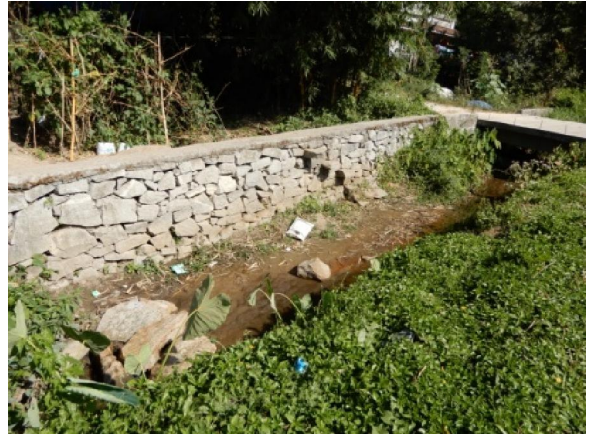
The structure is located in the Mangavayal watershed of Meppadi Gram panchayat. The site is to the downstream of the check dam mentioned above.

Side protection work in Mangavayal watershed

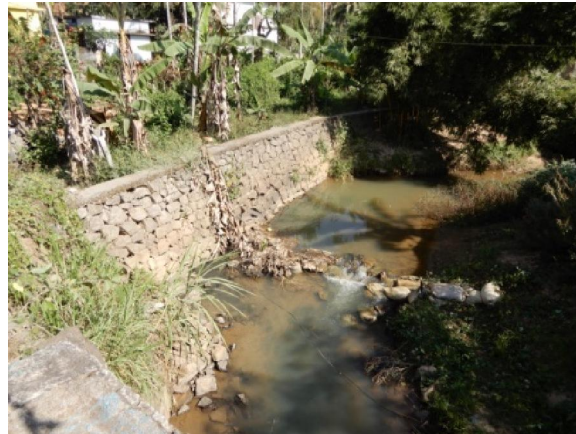
This structure is also located in the Mangavayal watershed of Meppadi Gram panchayat. The structure has suffered damage from the unprecedented flood during the month of August of 2018.

Side protection work in Mangavayal watershed that was partially damaged during the flood of August 2018
